HANSON QUARRY ROMAN ROAD, CLITHEROE, LANCASHIRE

Archaeological Investigation Report

Report Title: Hanson Quarry Roman Road, Clitheroe, Lancashire;
Archaeological Investigation Report

Version: v1
Issue Date: September 2022
Report Ref: 22-39

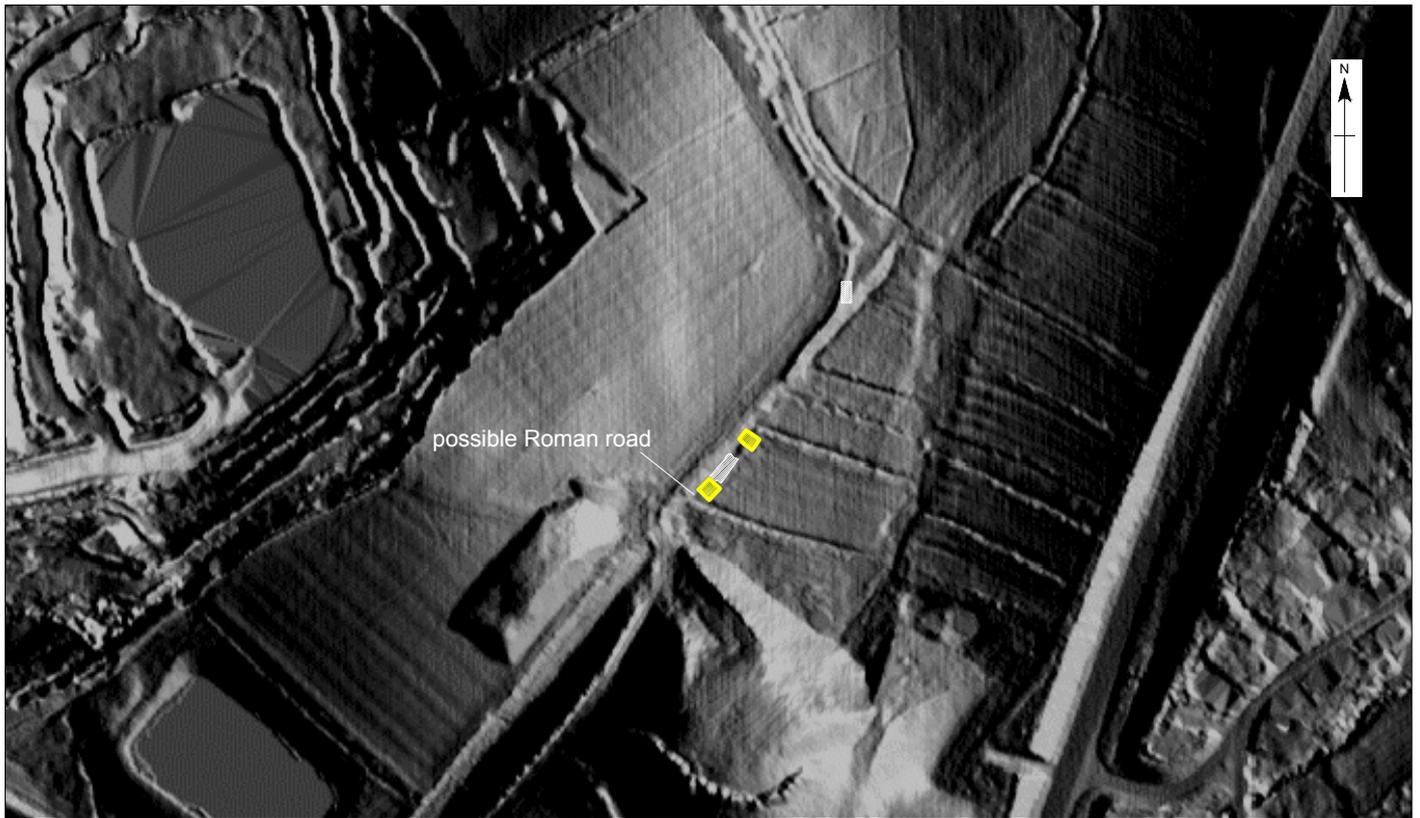
Figure 2

Hanson Cement Quarry Roman road: location of archaeological recording
overlain on 1m LiDAR DTM

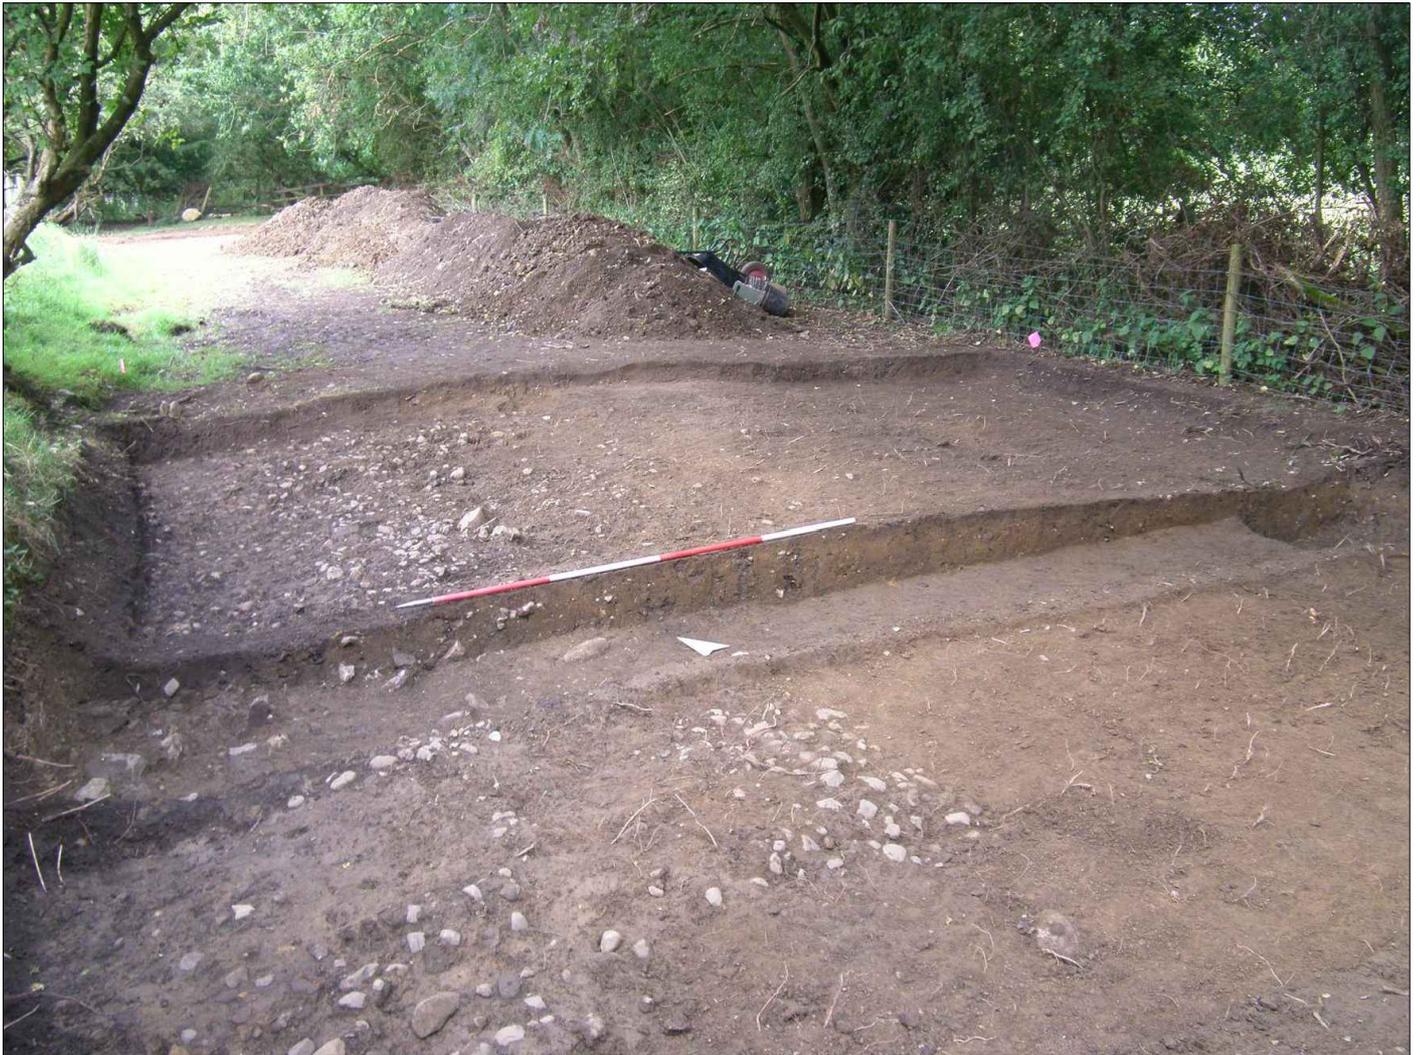
Figure 4

Trench 2, section

Hanson Cement Quarry Roman road: south-west facing section, Trench 2

4.1.1 The earliest archaeological deposit identified in Trench 2 was a layer of sculpted or redeposited boulder clay (**104**) up to 0.2m thick and 3.3m in width from north-west to south-east, overlying the undisturbed natural boulder clay (**115**). This formed a cambered surface onto which a cobbled road surface (**103**) had been laid. The cobbled surface (**103**) was observed over a width of 2.5m and continued beyond the north-western limit of excavation and under the modern quarry haul road (Fig. 4). Finds collected from the cobbled surface (**103**) included a sherd of medieval pottery and a sherd dating to the 18th or 19th century.

4.1.2 The cobbled surface (**103**) was overlain by a sandy clay deposit (**102**) which extended beyond the south-eastern limit of excavation. The sandy clay deposit (**102**) formed a cambered surface with a maximum depth of 0.3m and a width of 5.7m from north-west to south-east within the trench. A collection of finds was recovered from the sandy clay surface (**102**) which including 22 sherds of pottery ranging in date from the 18th to 20th century, indicating the period throughout which this surface was in use. The other finds comprised animal bone, clay pipe, heavily-corroded iron objects which were probably nails, and two fragments of crinoid fossil.

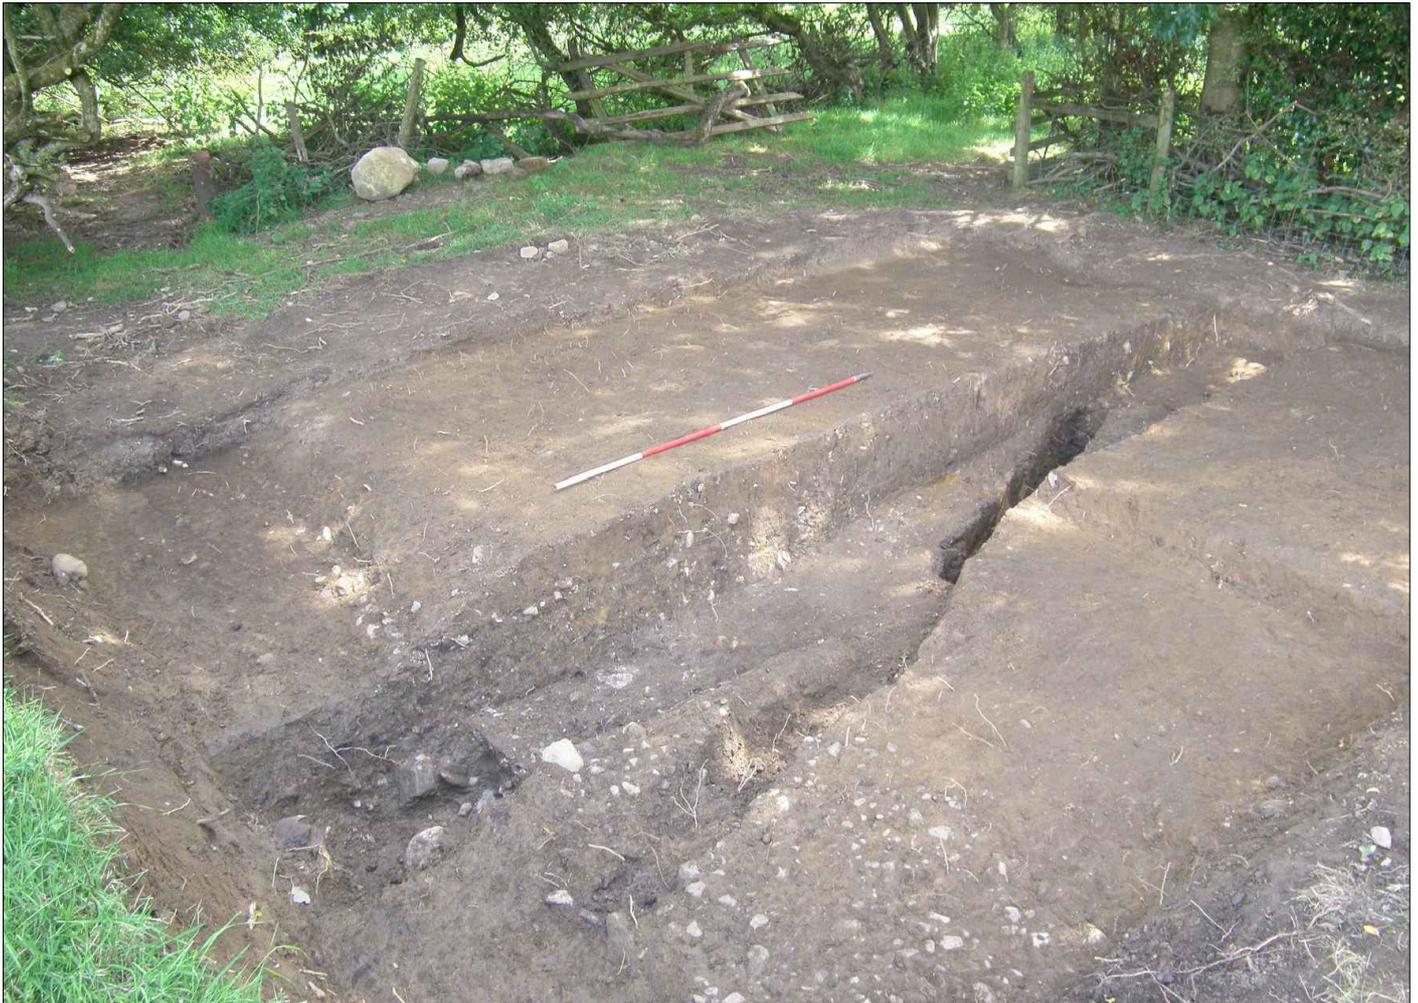
Figure 5

Trench 3, section

Hanson Cement Quarry Roman road: south-west facing section, Trench 3

4.2.1 Natural boulder clay (**115**) was overlain by a layer of redeposited boulder clay (**112**), up to 0.35m in depth. This deposit (**112**) was equivalent to deposit **104**, as identified in Trench 2, and may have lain in a shallow cut (**113**). The redeposited clay layer (**112**) survived over a width of 4.4m from north-west to south-east and formed a cambered surface on which an overlying cobbled road surface was laid (Fig.5).

4.2.2 The road surface consisted of a base layer of yellow clay (**114**) up to 0.08m in depth with a maximum width of 2.3m from north-west to south-east, which wasn't identified in Trench 1 or 2. A layer of small cobbles (**108**) that was up to 0.1m in depth with a maximum width of 2m from north-west to south-east, was pressed into the yellow clay layer (**114**) forming a road surface. The cobbled surface (**108**) was equivalent to the surface (**103**) identified in Trench 2, and appeared to have been worn through by a wheel rut. A single sherd of Roman samian ware pottery was

- 4.2.3 The cobbled road, comprising deposits **108**, **112** and **114**, was overlain by a sandy clay surface (**105**), equivalent to **102** in Trench 1. This again formed a cambered surface and represented a re-surfacing of the original road. The sandy clay surface (**105**) survived to a maximum depth of 0.4m and extended 6.7m from south-east to north-west, where it continued beyond the limit of excavation. A sherd of pottery dated to the 12th–14th century was recovered from the make-up of the surface (**105**) along with a piece of flint debitage which probably dated to the Mesolithic–Late Neolithic period and was considered to be a residual find in this context.

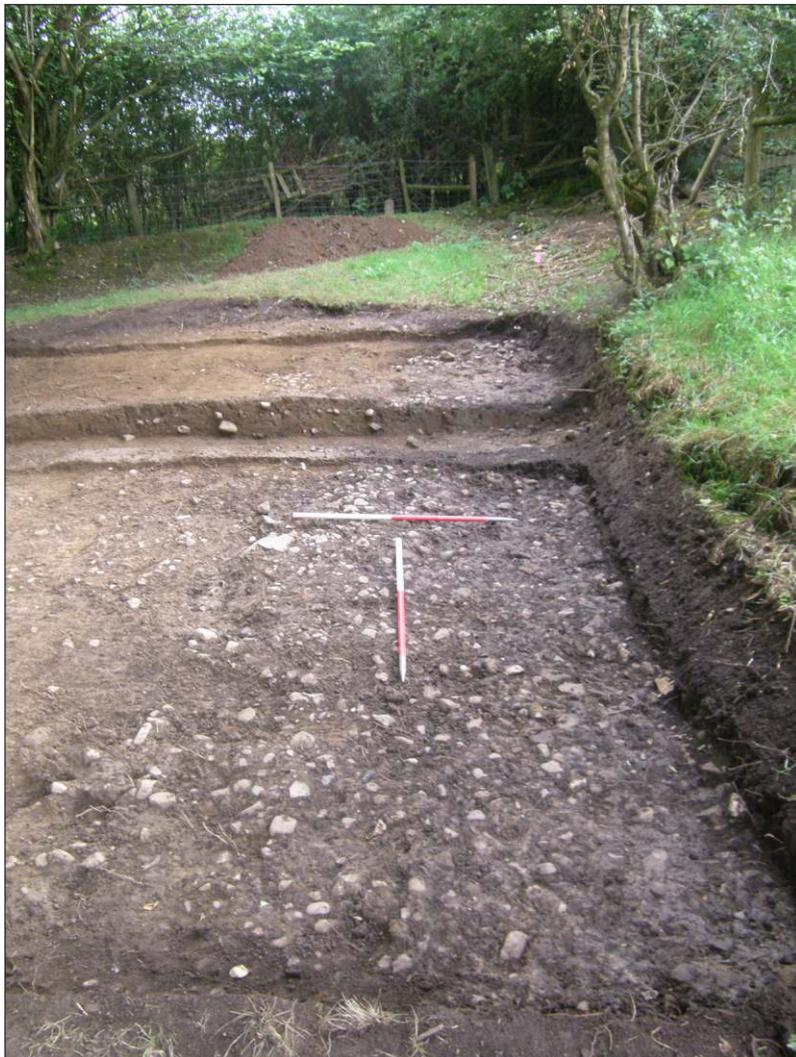
Plate 2

Hanson Cement Quarry Roman road: cobbled surface, Trench 2, facing south-west

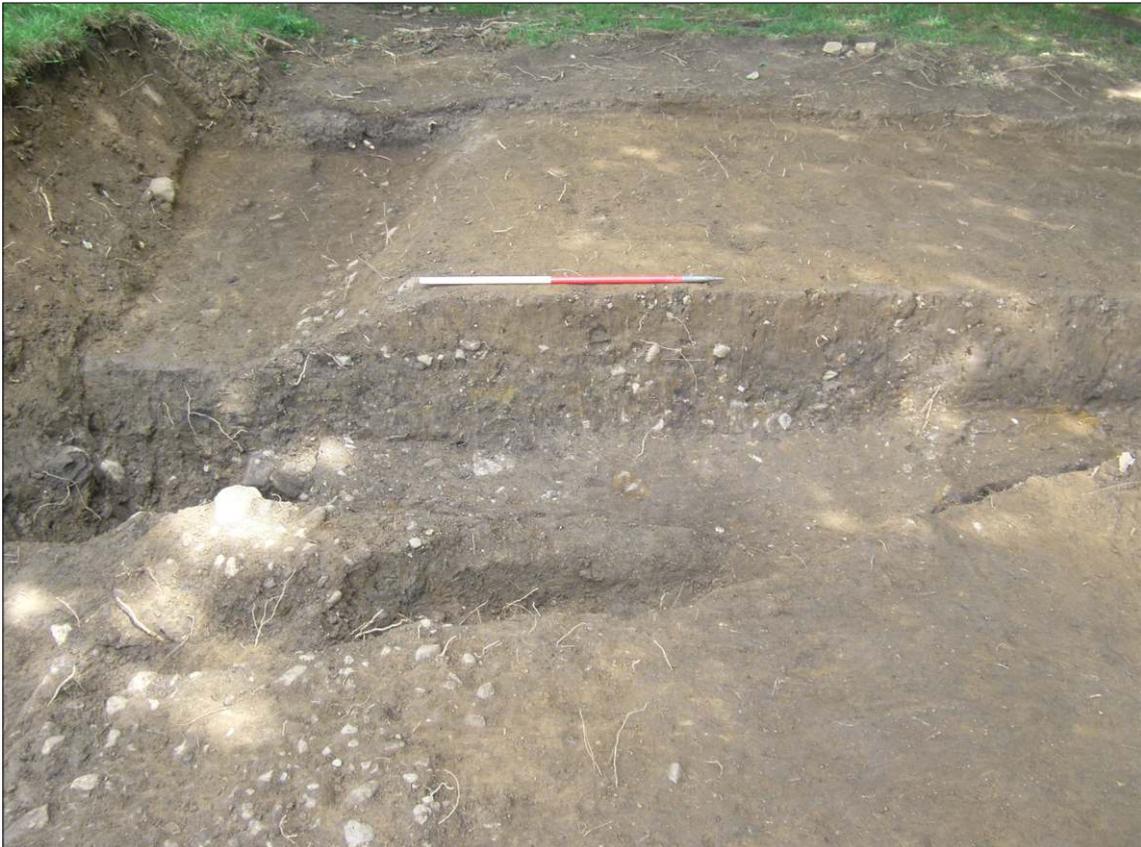
Plate 4

Hanson Cement Quarry Roman road: section showing cobbled surface with clay foundation, Trench 3, facing north-east
