SURVEY AND EXCAVATION  
FINAL REPORT

HANSON CEMENT QUARRY  
ROMAN ROAD, CLITHEROE,  
LANCASHIRE

prepared for  
Pendle Hill Landscape  
Partnership

NAA 21/100  
November 2021

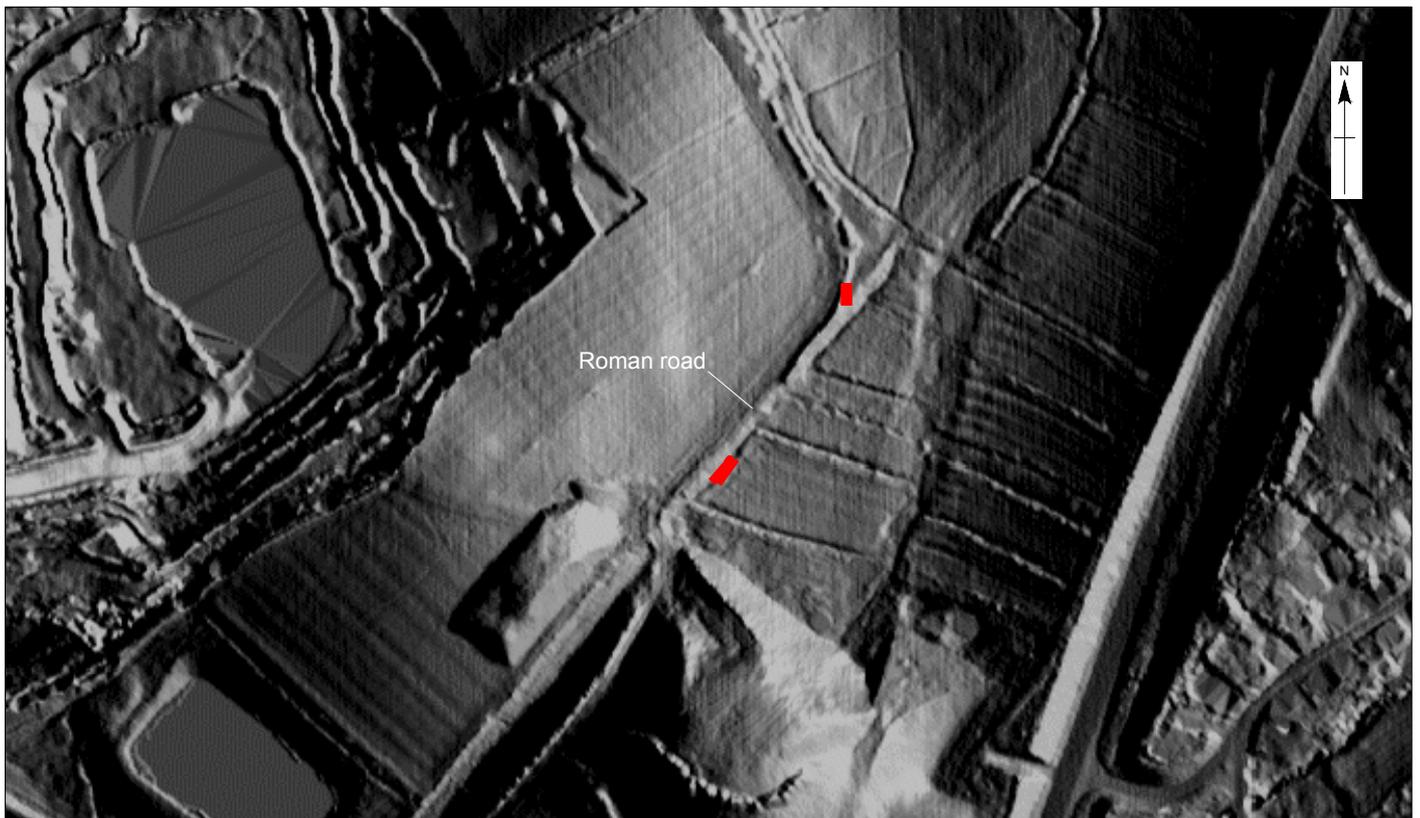
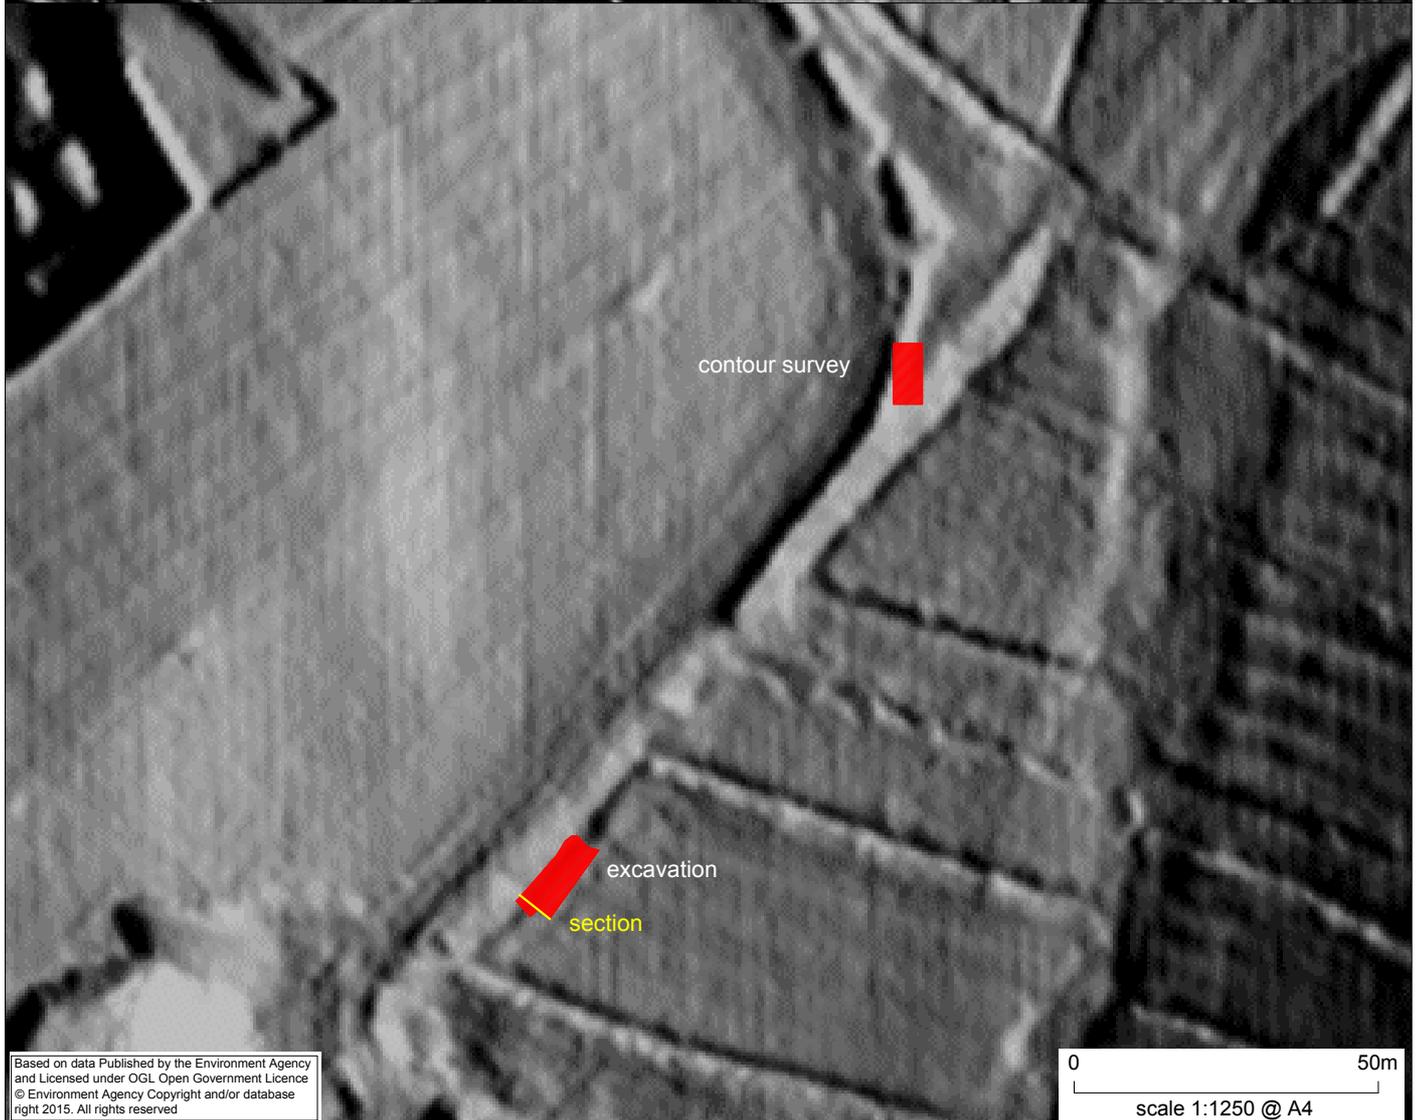
Surface contour plot of Roman road and quarry bank

- 6.1 The results of the topographical survey, using a dumpy level and an auger were processed to create a contour plot of the upper turfed surface of the earthwork and the surface of the underlying road (Fig. 3). The contour plot revealed that the underlying road surface was relatively flat and the agger was seen sloping down to the north-west. Only part of the road was surveyed due to the location of a modern fence, so the south-eastern edge of the road was not visible on the contour plot. The topographic and auger survey confirmed that the road continued along the course suggested by the Lidar results (Fig. 2).

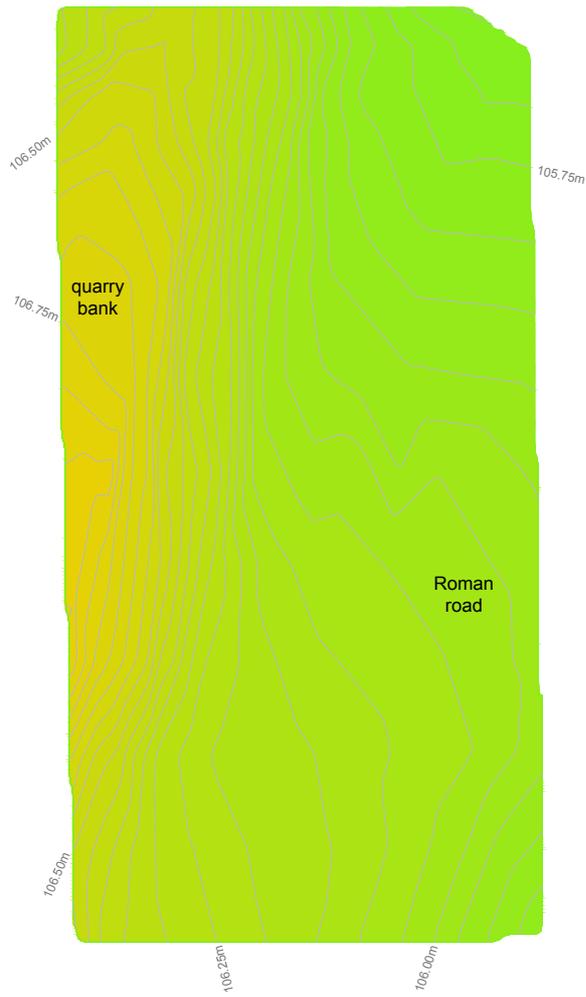
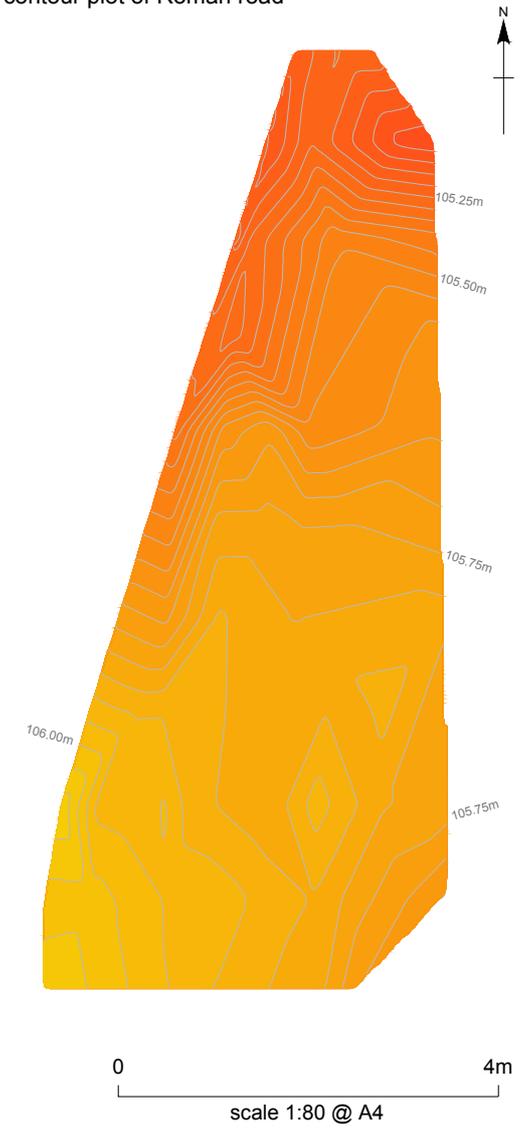
Sub-surface contour plot of Roman road

- 8.7 The contour plot resulting from the topographic and auger survey revealed that the road was present in this location and followed the course suggested by the results of the Lidar survey.

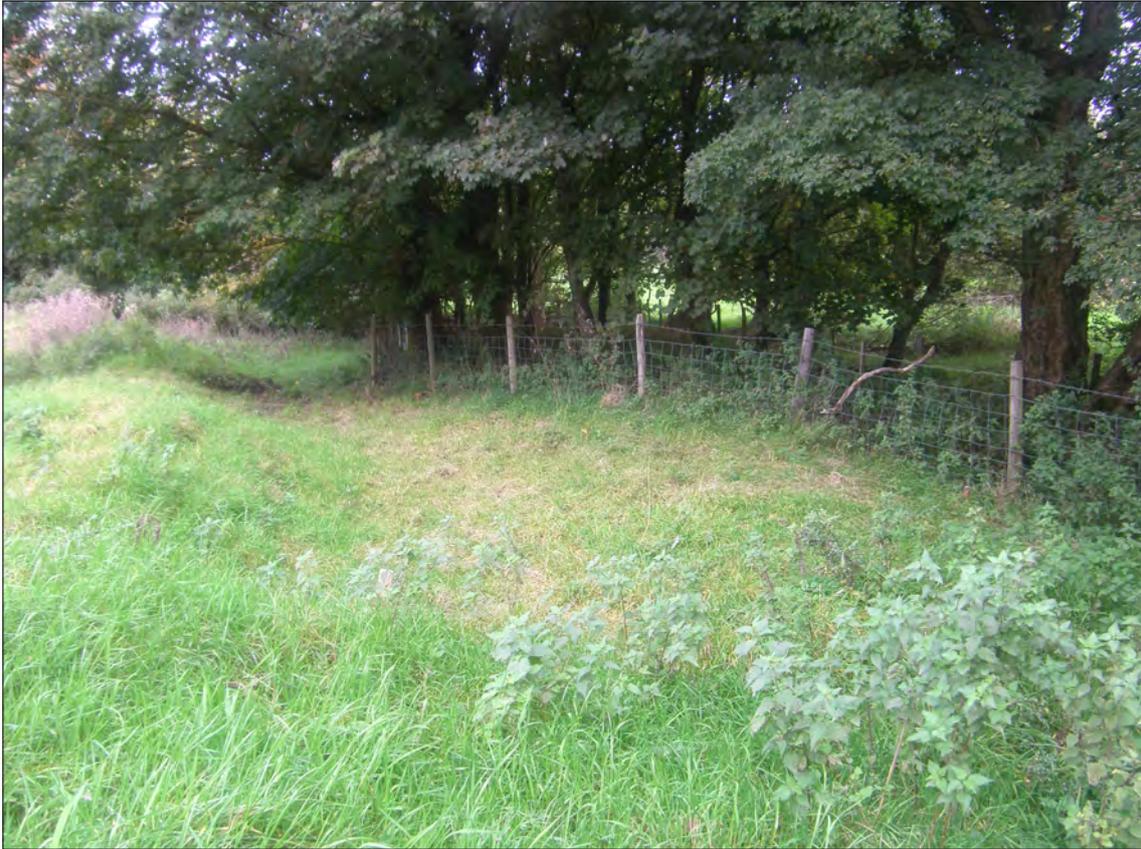
Plate 1

*Hanson Cement Quarry: site of initial topographic and augur survey, with surviving agger continuing under fence and into trees*

- 5.1 An initial survey was conducted with local volunteers on a section of the agger 100m north-east of the excavation site (Plate 1). This consisted of an examination of the overlying topography of the road by optical instrument (dumpy level), taking readings of relative height of the modern ground surface (Plate 2). A hand auger survey was then conducted at the same points as the topographic survey to create a profile of the buried surface of the Roman road by drilling through the post-Roman overburden soils until the stone surface of the road was encountered (Plate 3). This process was repeated on a second day to allow more volunteers to participate.

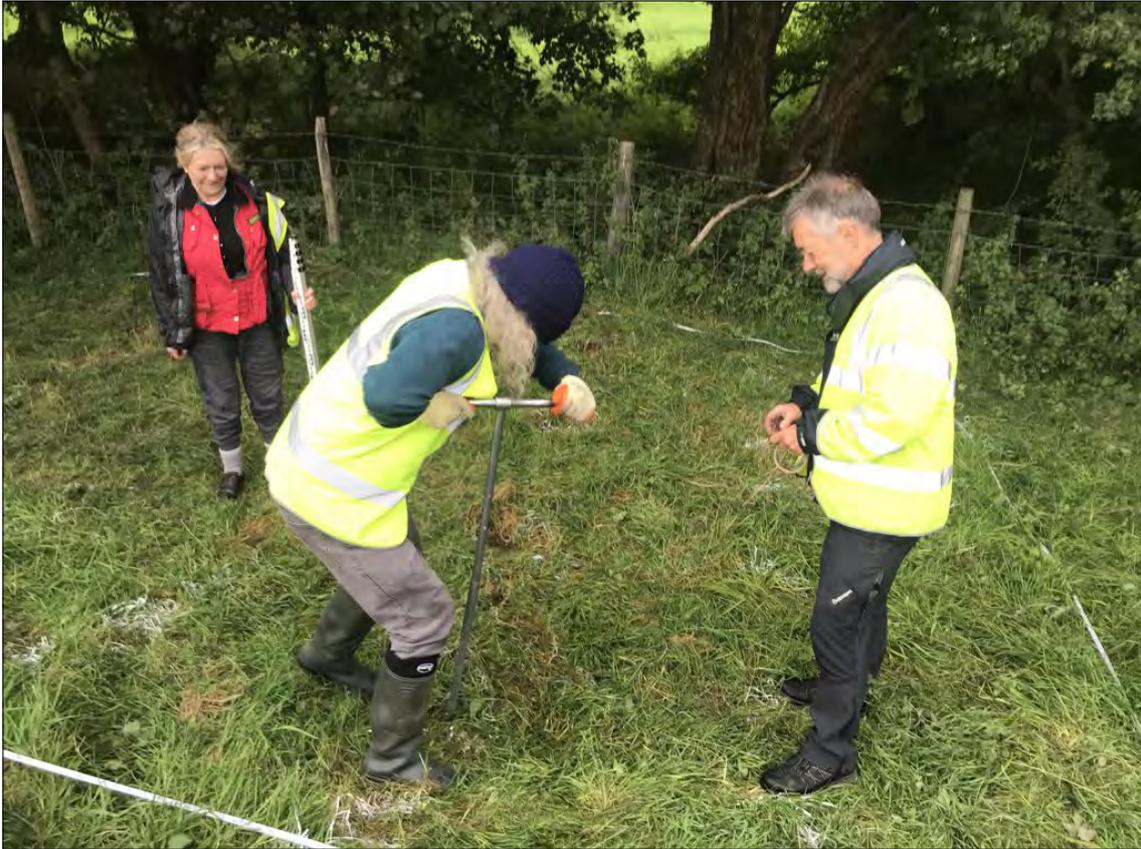
*Hanson Cement Quarry: volunteers participating in auger survey* Plate 3

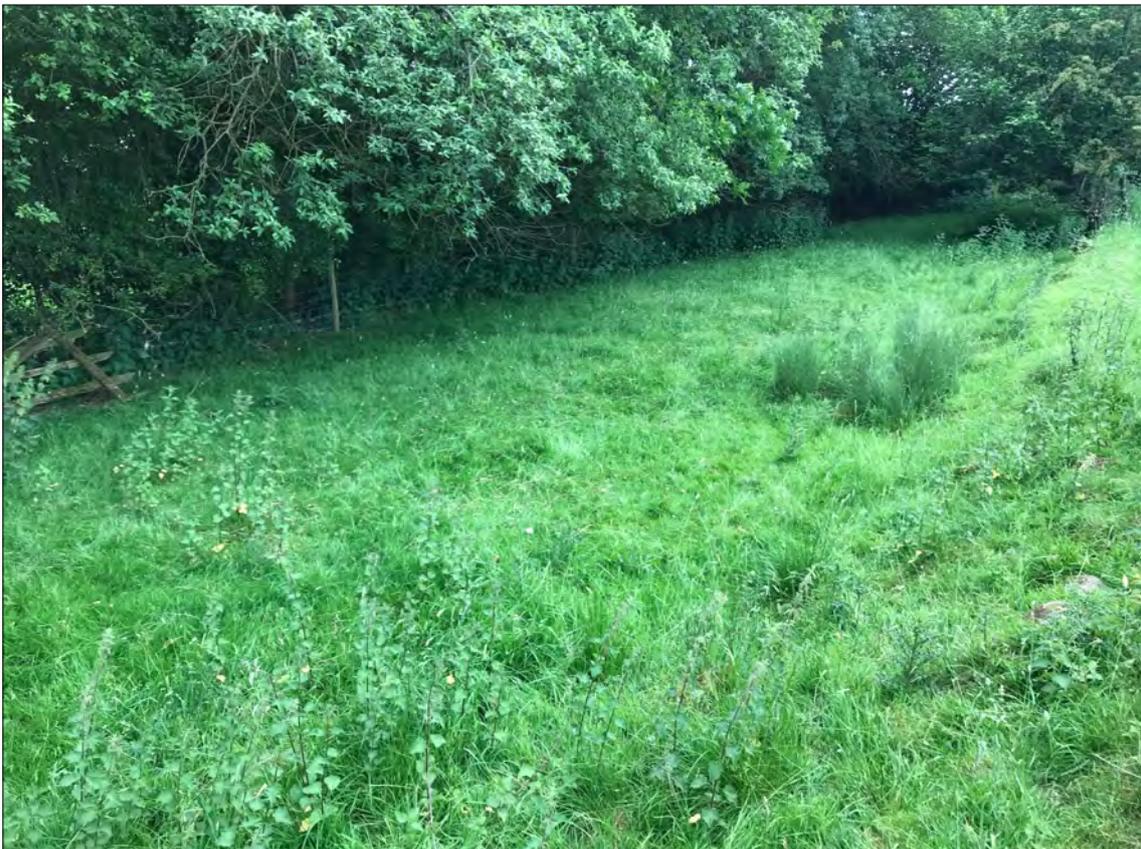
Plate 4

*Hanson Cement Quarry: the upstanding earthwork prior to excavation*

- 5.2 The area of excavation, within which the road survived as an upstanding earthwork (Plate 4), was to be stripped of overlying modern soils by mechanical excavator to expose the surface of the road. However, the unexpected nature of the later sand and clay surface overlying the stone road meant that the road was not properly identified at this stage and the methodology was adapted considering this. After identification of the road a slot was dug at the south-west end of the machined area to show the available transverse section (Fig. 3), and topsoil was stripped by hand to the south-west of the machined area to reveal the road surface.

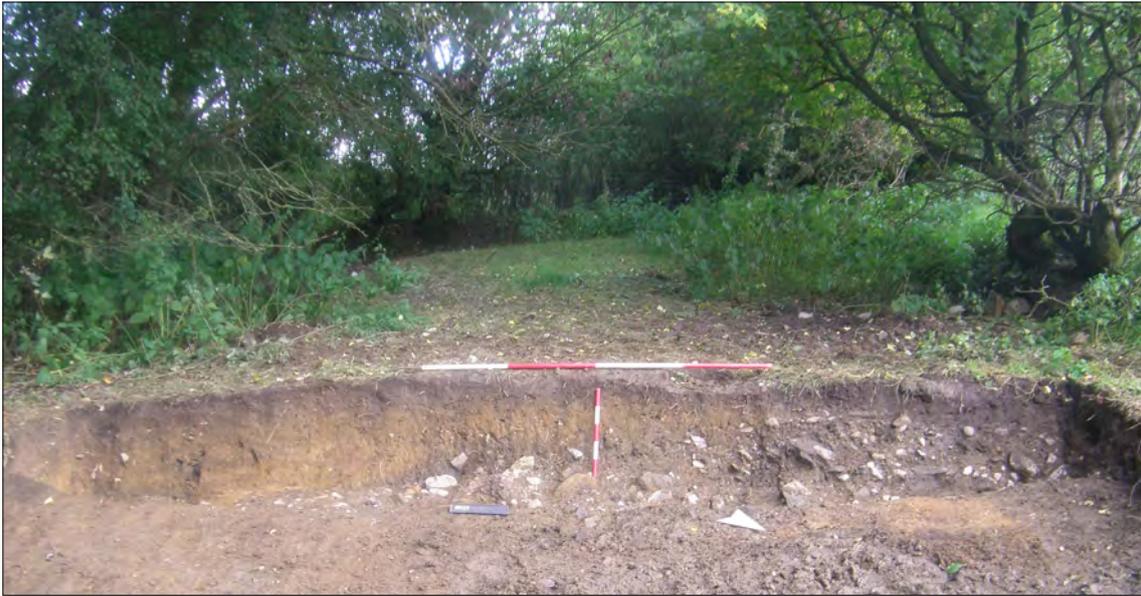
Plate 5

*Hanson Cement Quarry: section of upper surface showing agger, clay and stone surfaces, facing south-west*

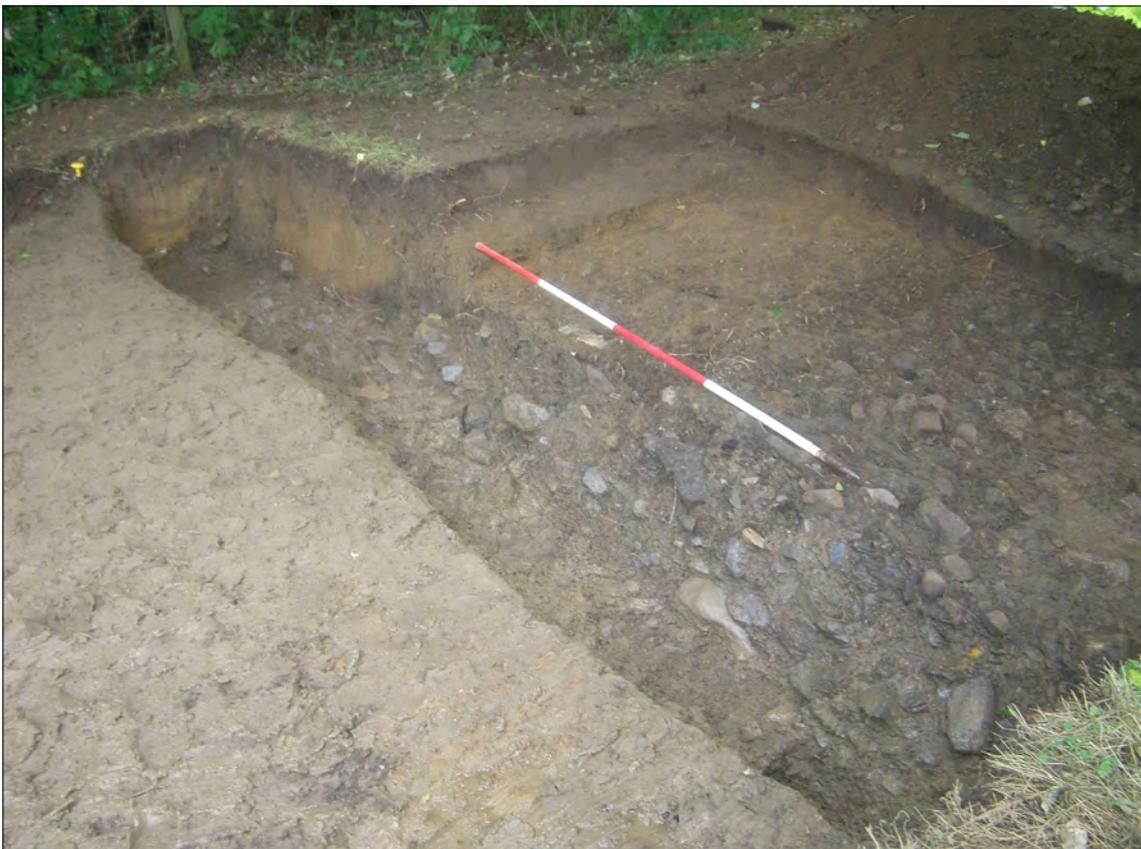
Plate 6

*Hanson Cement Quarry: oblique view of section with exposed road surface, facing south*

- 6.2 The earliest archaeological deposit identified was the foundation layer of the Roman road (**12**), which measured at least 0.5m in depth at the centre of the road. The foundation was seen to a width of 4m in section and continued under the unexcavated made ground to the north-west. A total width of over 6m could be estimated, assuming that the highest point of the road represented its centre (Plate 5). A surface layer of smaller stones (**11**), up to 8cm thick, overlay the foundation, although there was little to differentiate it from the underlying deposit other than size of stone used in construction, and it was not positively identified beyond pit **13** where it was not exposed in plan (Plate 6).

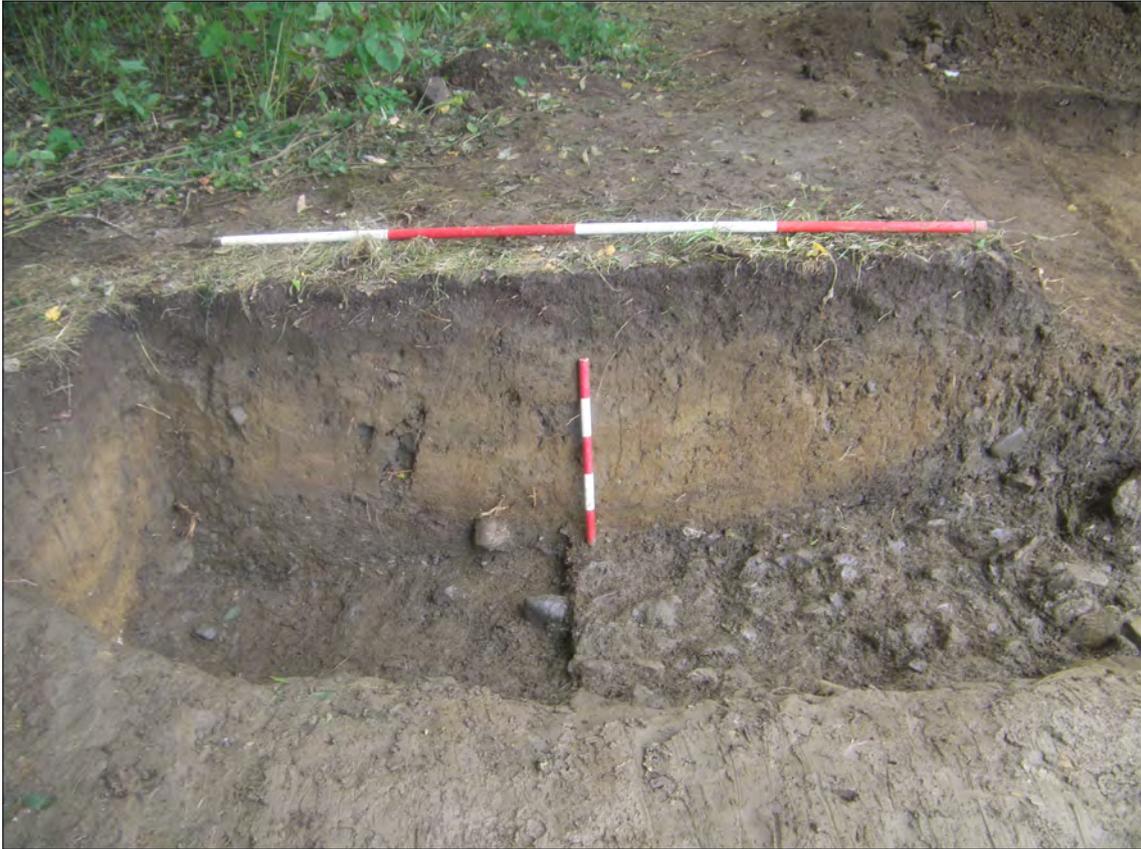
*Plate 7*

*Hanson Cement Quarry: south-east end of section showing possible roadside ditch, facing south-west*

- 6.3 The edge of a possible roadside ditch (**16**) filled with gravel (**15**) eroded from the road surface was identified at the south-east side of the road (Plate 7). However, the extent of this material to the south-east could not be established within the limit of excavation and it may have been a spread of material overlying a steeper area of the natural slope of the hillside.

- 8.3 There is evidence for a roadside ditch along the south-eastern edge of the road but any evidence for a counterpart on the north-western side was beyond the limit of excavation and may now lie under the modern haul road.
